ELECTRODES FOR FUNCTIONAL NEUROMUSCULAR STIMULATION

Quarterly Progress Report #7 1 April, 1995 - 30 June, 1995

B.2 Electrode Testing: Corrosion Testing of Cuff Electrodes

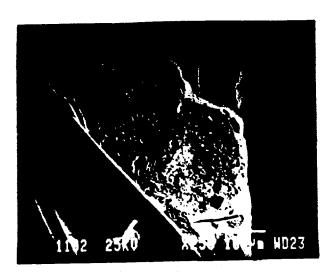
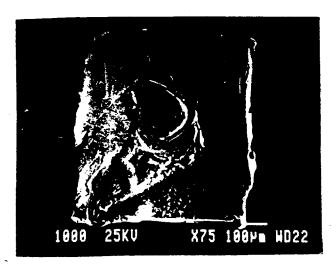
In direct association with the weld zone on the back side, distortions and voids were found on the faces of 4 contacts. The distortions, seen on two different contacts, are in areas where excessive heat was likely generated during the weld. In one case, the distortion overlies a large weld nugget (Figure 3.a, 3.b). In the other instance, the distortion overlies an area that appears to contain some weld metal (Figure 3.c, 3.d), probably originating from a failed weld attempt. The voids with the very round shape, as shown in Figure 3.a appear to indicate gas escape. In other cases, the voids were irregular in shape and appear to be from inclusions or other metallurgical origins (Figure 4). A small slit was also found in the interior of another contact overlying the weld area, as shown in Figure 5, but the view of the weld does not clearly indicate the weld as the source of this slit.

Figure 3: SEM photomicrographs representing distortions and round voids overlying weld zones. The front face is presented in 3.a and 3.c, while the back faces are shown in 3.b and 3.d. The distortion seen in 3.a overlies the large weld nugget shown in 3.b. The hook-shaped distortion seen in the lower left corner of 3.c can also be seen in 3.d in an area of weld metal.

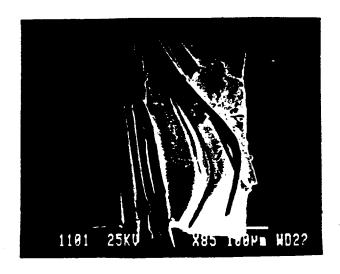
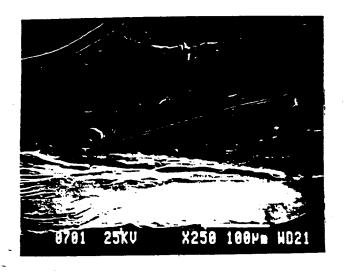
Finally, in two instances, actual tears in the platinum foil were created by the wires, as shown in Figure 9.a-d. These appear to have been created as the wire pressed entirely through the contact, and are clearly seen by the photographs taken on the back side of the contact where the position of the

wire in relation to the tear is shown.

Figure 9: SEM photomicrographs of the two instances where the wires apparently tore through the platinum foil. A tear is seen in the lower right corner of 9.a corresponding to the wire dent on the lower edge of the back side of the contact as shown in 9.b. The other case where a tear occurred is shown on the face in 9.c and on the back in 9.d.

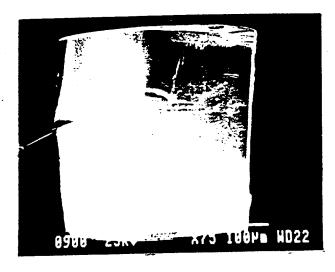
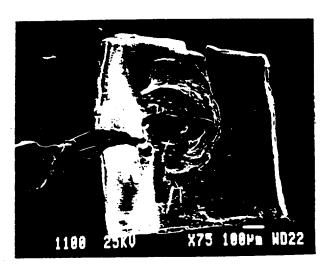
In these cuffs, 12 of the 36 contacts had cracks or tears, originating from the outer edge of the contact near the lead wire. In all instances, these cracks were found to be parallel to the line of the lead wires, which is perpendicular to the direction of the stretched sheeting, and hence, to the curl of the cuff.

Enough stress was placed on these pieces of platinum foil to create cracks. This stress may have originated with the curling of the cuff, particularly in those areas with the additional stiffness of the lead wire. It should be noted that these cuffs experienced some additional handling than might normally be experienced, both before and after the stimulation period. The possibility that this additional handling may have created cracks in the foil should be considered, particularly as preliminary examination of contacts in cuffs that were implanted *in vivo* for periods of over 6 months has found no cracks.

Figure 11: SEM photomicrographs representing the tears extending from the edge of the contacts. These tears run perpendicular to the direction of the curl of the contact and originate in the area of the lead wires. A higher magnification view of the crack shown in 11.c is presented in 11.d.

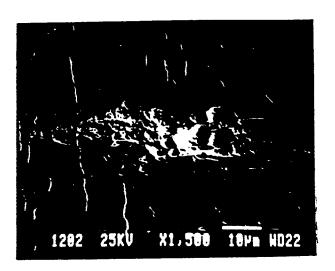
Lines of shallow pits were found on many contacts. These lines were primarily parallel to one another and extended in some instances for the entire length of the contact. These pit lines were also generally parallel to the edge of the contact and were found on the back sides of the contacts. Contaminant or defect created during the rolling of the sheet of foil may be responsible for these. Occasional diagonal lines containing shallow pits were also found on some contacts. Isolated pits and isolated regions of pits were seen in both exposed and unexposed regions of the platinum, as well as on the back sides. Examples of these defects are presented in Figure 12.a-d.

Figure 12: SEM photomicrographs representing the metallurgical defects found on the contacts. These defects were not correlated with either the exposed surface of the contacts, nor with the stimulation of the contacts.

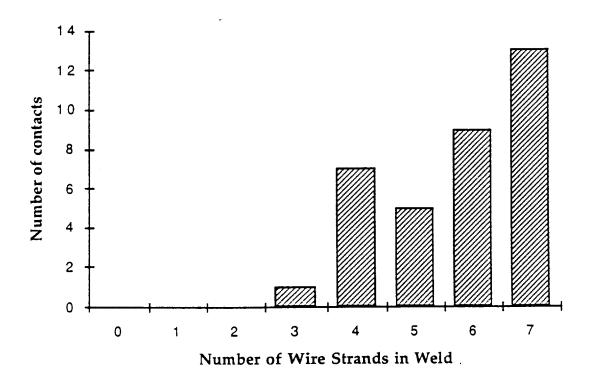
In the examination, the welds typically involved most of the wire strands. The histogram shown in Figure 13 demonstrates that of the 35 contacts where it was determinable, over two thirds of the contacts had 6 or more wire strands contained within a weld. These data show that despite a cumbersome process, the spot welding was generally successful at effecting most of the wire. In a visual examination, this would indicate to the welder that the wire was well bonded to the foil.

Figure 13: Histogram showing the distribution of the number of wire strands involved in a weld. The data show that most contacts were welded to the lead wire by 6-7 wire strands.

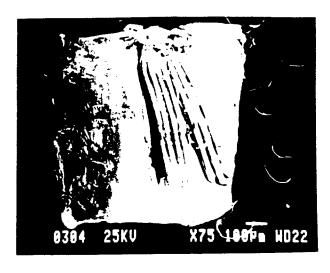
However, both wire strands and weld bonds were found to have failed. Broken wire strands were seen in areas adjacent to the weld in 6 different contacts, as represented in Figure 14.a-c. During the welding, the wire strands heat and the molten metal goes into the weld nugget. This leads to thinning of the wire strands in those areas, as shown in Figure 14.c-d, and subsequent reduced strength. When the contacts were extracted from the sheeting, tension was applied to the lead wire, which could have initiated wire strand breaks. However, some tension is also applied to the lead wires during fabrication, cleaning, etc., and may have played a role in these failures.

Figure 14: SEM photomicrographs representing some of the effects of the welding on the wire strands. Broken wire strands are shown in 14.a-c. The thinning of the wire strands is shown in 14.c and 14.d.

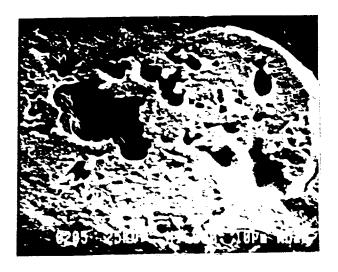
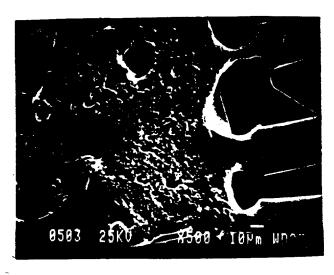
In those weld nuggets containing numerous voids, the appearance of the weld nugget and the adjacent wire strands is suggestive of some corrosion. Particularly on the wire strands, apparent surface pits can be seen, as shown in Figure 17.d. While these may be corrosion pits, they are of limited frequency and size and are not readily apparent as failure sites. Wires with the appearance shown in the figure were seen in only a few other contacts. In ideal cuff fabrication, the back side of the contact should be sealed off from the *in vivo* environment by the bonded sheeting, effectively excluding the ionic path requirement for a corrosion cell. However, ineffective bonding or other inadequacies in the cuff fabrication may allow for

some fluid entry into this region, making corrosion cells possible.

Figure 17: SEM photomicrographs weld zones with large numbers of voids and having a coarse, grainy appearance. These areas, as well as the wire strands in 17.d, are suggestive of limited corrosion.

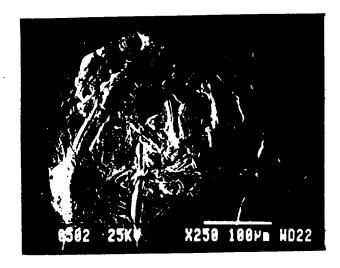
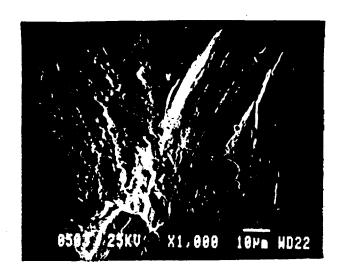
For those contacts stimulated at 2 and 3 mA, the surfaces of the contacts in the exposed region were found to contain a large number of pits, as shown in Figure 20. These pits are distinct from those seen in 0 and 1 mA stimulated contacts in that they are limited to the apparent exposed window region, are predominantly round, and are found in high numbers.

The contact presented in Figure 20.c has a clearly delineated circular area containing pits which would seem to mark the borders of the window, even though the area is not consistent with the gouge marks. Measurement of the diameter of this circular area shows that it is not 0.7 mm, but instead is a much smaller 0.4 mm. If this represents the true size of the window, the charge density is then over $100 \ \mu\text{C/cm}^2$. If the gouge marks on the contacts are used as the window borders, charge densities on these contacts may have ranged from $13 - 120 \ \mu\text{C/cm}^2$.

The pitting shown on the higher amplitude stimulated contacts is certainly cause for concern. The release of corrosion products and the loss of metal mass could effect the safety and performance of implanted metal.

Figure 20: SEM photomicrographs of contacts stimulated at the higher amplitudes. Extensive pitting is seen in the exposed window due to high charge densities. Using the border of the pitted, circular area in 20.c as the edges of the window, the charge density exceeded 100 μ C/cm².
